# TECHNICAL SERVICE BULLETIN

## Cadillac Water Pump Installation Procedures – 4.1L, 4.5L and 4.9L (1985-1995)

ASC PART NUMBER(S): WP-627

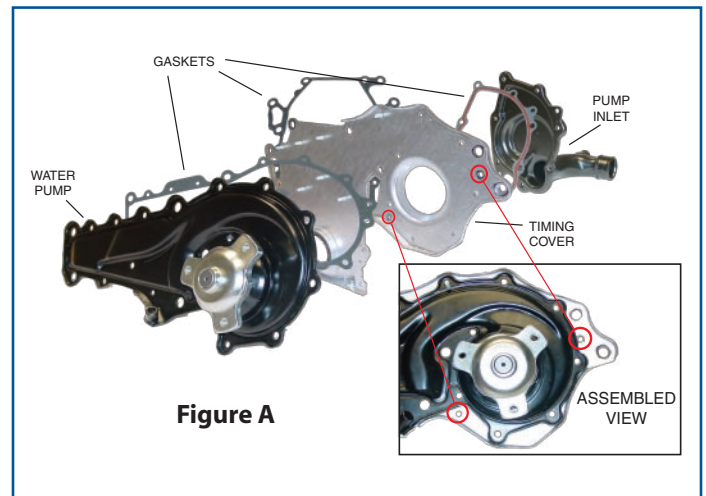
**CONDITION:** The inlet cover gasket, located between the timing cover and the inlet cover, shifts and causes a coolant leak that appears to be a leak from the water pump.

**CAUSE:** These particular Cadillac models' water pumps are tough to get to under the hood because of their tight location, and the pumps are secured with many fasteners. There are two bolts located very close to the outside edge of the water pump that must not be disturbed during the pump's replacement.

**CORRECTION:** Avoid unnecessary removal of these particular bolts when replacing the water pump. (See figure A)
