TECHNICAL SERVICE BULLETIN

General Motors Quad 4 Installation Advisory – 2.3L (1987-1995)

ASC PART NUMBER(S): WP-721

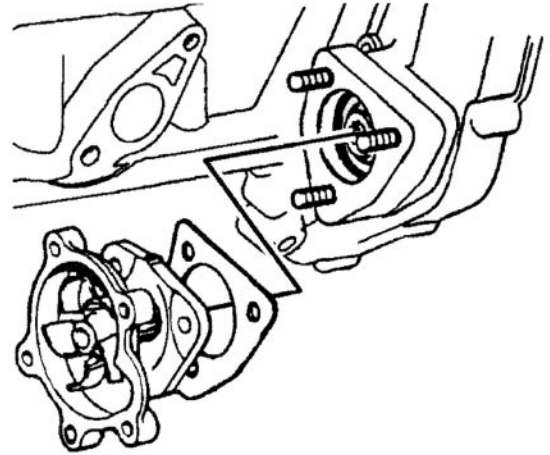
#1

CONDITION: The replacement water pump bearing is pressed downward as the mounting bolts are tightened, damaging the bearing.

CAUSE: Improper seating of the water pump bearing shaft into the bore in the timing chain idler bearing.

CORRECTION: To ensure proper installation, special attention must be paid to the proper seating of the splined end of the bearing shaft into the splined bore in the timing chain idler bearing.
