TECHNICAL SERVICE BULLETIN

Mazda MVP Uses One of Two Different Water Pumps - V6 3.0L (1995-1996)

ASC PART NUMBER(S): WP-764 & WP-9165

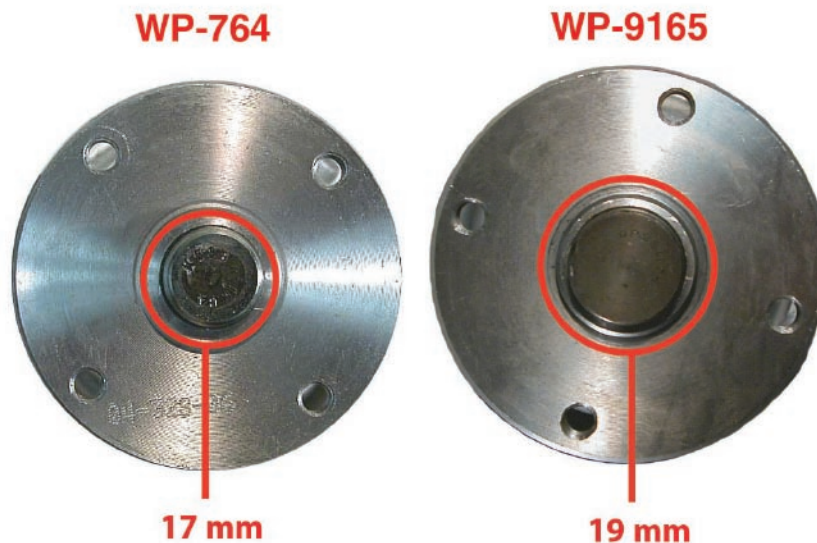
CONDITION: Installation of the incorrect water pump will make it impossible to install the fan clutch or allow the fan clutch to be tightened off center causing misalignment resulting in underhood part(s) damage.

CAUSE: The OE changed the fan clutch between model years where the vehicle could be equipped with either pump. The WP-764's bearing shaft pilot for the fan clutch is 17mm in diameter. WP-9165's bearing shaft pilot for the fan clutch is 19 mm in diameter. The differences in diameter create the above conditions when installation is attempted using the incorrect pump.

CORRECTION: Double-check the water pump and fan clutch applications, paying specific attention to the production month. Also, verify that the fan clutch pilot and bearing shaft diameters match within .5 mm to be sure you are installing the correct water pump.
