TECHNICAL SERVICE BULLETIN

Tool Needed For Replacing Timing Chain Driven Water Pump on 2.0L, 2.2L & 2.4

GM Engine: Buick (2011-10); Chevrolet (2012-02); Chevrolet Truck (2012-10); GMC Truck (2012-10); Oldsmobile (2004-02); Pontiac (2010-02); Saab (2011-03); Saturn (2010-00)

ASC PART NUMBER(S): WP-9228

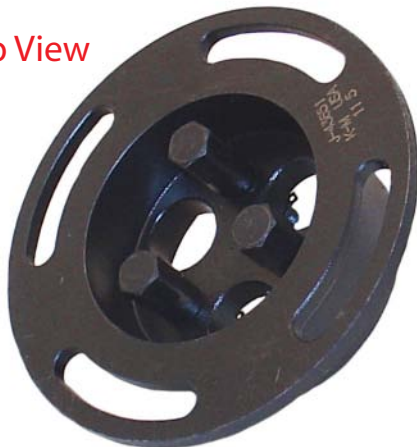
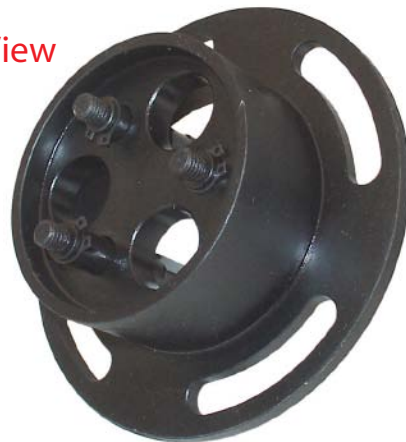
Water Pump Sprocket Holding Tool

Replacing this water pump requires a special tool to secure the water pump sprocket. Failure to do so will result in a whining noise from the front of the engine, an engine vibration or significant engine damage. If the sprocket is not secured, the balance shaft weights may rotate the chain after sprocket is unbolted, or the balance shaft tensioner will ratchet out resulting in a tight chain and overloaded components.

Remove the water pump access plate from the timing cover and install J 43651 Water Pump Sprocket Holding Tool; or equivalent. Follow manufacturer's water pump installation procedure.

If tool was not used, it will be necessary to remove the front cover and reset the balance shaft tensioner by following the manufacturer's service procedure. Failure to follow these installation guidelines will void product warranty.
