TECHNICAL SERVICE BULLETIN

Cadillac Water Pump Installation Procedures – 4.1L, 4.5L and 4.9L (1985-1995)

AIRTEX PART NUMBER(S): AW5023

ASC PART NUMBER (S): WP-627

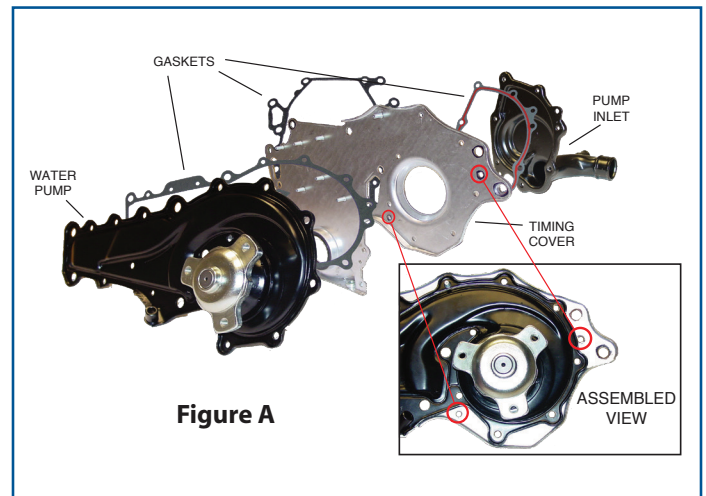
CONDITION: The inlet cover gasket, located between the timing cover and the inlet cover, shifts and causes a coolant leak that appears to be a leak from the water pump.

CAUSE: These particular Cadillac models' water pumps are tough to get to under the hood because of their tight location, and the pumps are secured with many fasteners. There are two bolts located very close to the outside edge of the water pump that must not be disturbed during the pump's replacement.

CORRECTION: Avoid unnecessary removal of these particular bolts when replacing the water pump. (See figure A)
