# TECHNICAL SERVICE BULLETIN

## Dodge Trucks & Jeeps Coolant Leak/Unnecessary Water Pump Replacement - 3.9L V6, 5.2L and 5.9L V8 (1993-2003)

AIRTEX PART NUMBER(S): AW7160

ASC PART NUMBER(S): WP-9126

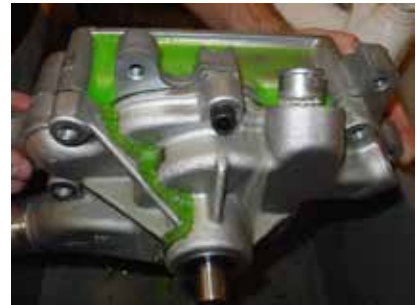
Figure 1

**CONDITION:** A coolant leak from a source above the water pump or from an improperly installed bypass tube on the water pump itself will cause coolant to pool on top of the timing cover. This coolant then rolls across the front of the pump and behind the pulley, making the pump appear to leak from the weep hole (Figure 1). This often results in unnecessary pump replacement.

**CORRECTION:** When replacing this pump, the supplied bypass tube should be installed with thread sealant and should be properly tightened before installation of the pump. The bypass hose and clamp should be inspected for wear, holes, or other flaws before they are reused and the area should be inspected for evidence of other leaks, such as from the thermostat housing. The original leak that prompted the pump to be changed may still be present and will need to be addressed.

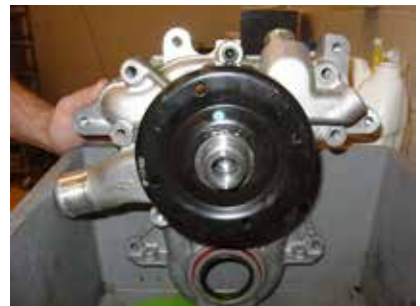
Figure 2

**CAUSE:** The pulley on this pump completely covers the face of the pump, making the correct diagnosis difficult (Figure 2). The bypass tube that is shipped loose in the box is often installed without sealant or is not tightened properly. The subsequent leak can cause antifreeze to gather on top of the timing cover, which is difficult to see. There are other components above the water pump, including the thermostat housing and the bypass hose, that can leak and cause antifreeze to gather in the same place and eventually mimic a leaking water pump.
