TECHNICAL SERVICE BULLETIN

General Motors Quad 4 Installation Advisory – 2.3L (1987-1995)

AIRTEX PART NUMBER(S): AW5043

ASC PART NUMBER(S): WP-721

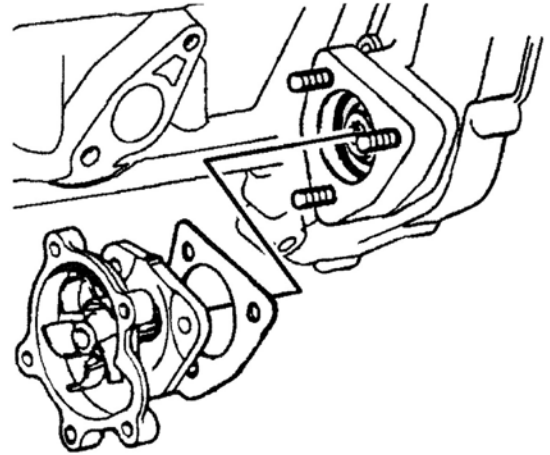
#1

CONDITION: The replacement water pump bearing is pressed downward as the mounting bolts are tightened, damaging the bearing.

CAUSE: Improper seating of the water pump bearing shaft into the bore in the timing chain idler bearing.

CORRECTION: To ensure proper installation, special attention must be paid to the proper seating of the splined end of the bearing shaft into the splined bore in the timing chain idler bearing.
