TECHNICAL SERVICE BULLETIN

Coolant Leak 2001-1996 Infinity, 2001-1995 Nissan w/VQ30DE 3.0L 2003-2001 Infinity, 2003-2001 Nissan w/VQ35DE 3.5L

AIRTEX PART NUMBER(S): AW9309 ASC PART NUMBER(S): WP-9122

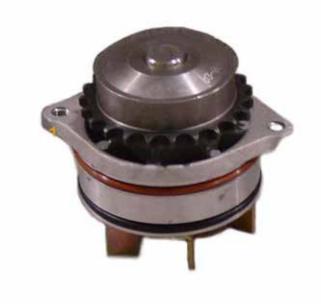
CONDITION: A severe coolant leak from the water pump's weep holes causes the coolant to destroy the pump's bearing, as well as leak into the engine's oiling system. Catastrophic engine failure can result.

CAUSE: This engine's water pump is buried beneath the timing cover since it is internally driven off the engine's timing chain. Since the front of the pump has direct contact with the engine's oiling system, the weep holes have been rerouted. Leaking coolant is channeled back through the pump and into the engine block. Therefore, if the water pump seal fails, the noticeable leaks will occur as coolant exits the left side of the engine block just below the thermostat housing.

CORRECTION: Be aware of the potential leak points and do not ignore the signs of a leak. It also is recommended that the water pump be changed whenever servicing the timing chain and/or internal timing components.
