SPECIAL ASSEMBLY INSTRUCTIONS

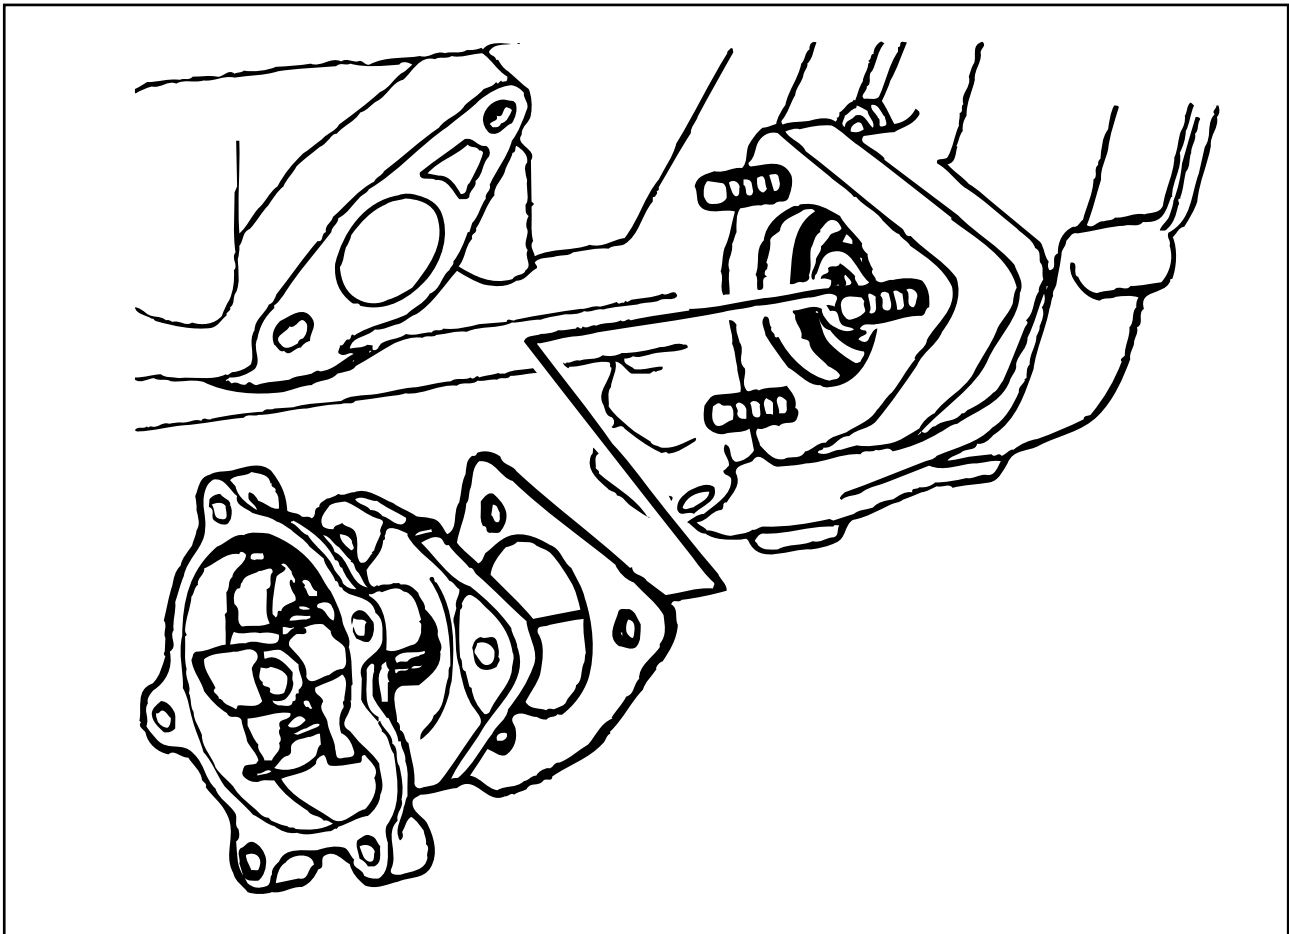
To avoid damage to the bearing in this pump, the splined end of the bearing shaft must be installed properly. Special attention must be paid to the proper seating of the splined end of the bearing shaft into the splined bore in the timing chain idler bearing. Improper fit may cause the bearing to be pressed downward as the mounting bolts are tightened.

In addition, please note that the replacement water pump may not appear to seat fully. There may be about a 1/4" gap between the timing chain cover and the pump's gasket surface. This spacing is normal. The timing chain idler gear is internally spring-loaded to eliminate spline noise and this gap will diminish as the pump is tightened down. The pump to timing cover mounting bolts should be tightened in a staggered, side-to-side fashion to their proper torque. Refer to repair manual for proper bolt torque values.
