TECHNICAL SERVICE BULLETIN

Coolant Leak

2003-2002 Infinity I35 3.5L & 2003-2002 Nissan Altima 3.5L

AIRTEX PART NUMBER(S): AW9426

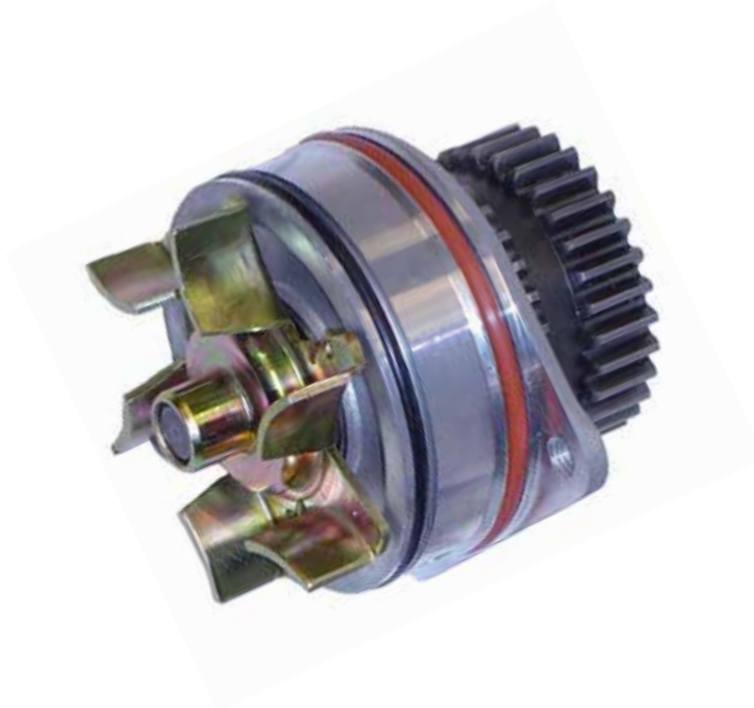
CONDITION: A severe coolant leak from the water pump's weep holes causes the coolant to destroy the pump's bearing, as well as leak into the engine's oiling system. **Catastrophic engine failure can result.**

CAUSE: This engine's water pump is buried beneath the timing cover since it is internally driven off the engine's timing chain. Since the front of the pump has direct contact with the engine's oiling system, the weep holes have been rerouted. Leaking coolant is channeled back through the pump and into the engine block. Therefore, if the water pump seal fails, the noticeable leaks will occur as coolant exits the left side of the engine block just below the thermostat housing.

CORRECTION: Be aware of the potential leak points and do not ignore the signs of a leak. It also is recommended that the water pump be changed whenever servicing the timing chain and/or internal timing components.
