# TECHNICAL SERVICE BULLETIN

## Coolant Leak

**2001-1996 Infinity, 2001-1995 Nissan w/VQ30DE 3.0L  
2003-2001 Infinity, 2003-2001 Nissan w/VQ35DE 3.5L**

ASC PART NUMBER(S): WP-9122

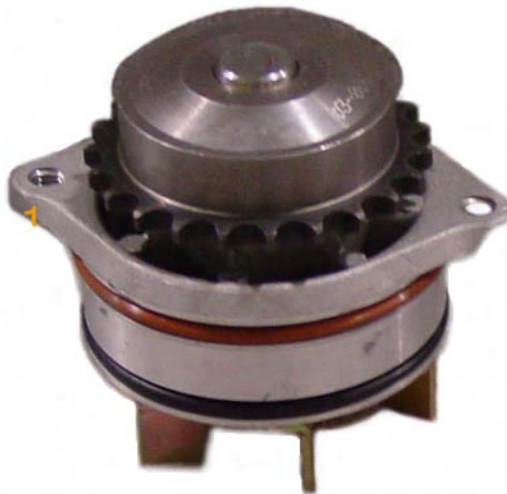
**CONDITION:** A severe coolant leak from the water pump's weep holes causes the coolant to destroy the pump's bearing, as well as leak into the engine's oiling system. **Catastrophic engine failure can result.**

**CAUSE:** This engine's water pump is buried beneath the timing cover since it is internally driven off the engine's timing chain. Since the front of the pump has direct contact with the engine's oiling system, the weep holes have been rerouted. Leaking coolant is channeled back through the pump and into the engine block. Therefore, if the water pump seal fails, the noticeable leaks will occur as coolant exits the left side of the engine block just below the thermostat housing.

**CORRECTION:** Be aware of the potential leak points and do not ignore the signs of a leak. It also is recommended that the water pump be changed whenever servicing the timing chain and/or internal timing components.
